Filter Temperature Sensor Locations and Feed Thru Pins *after* 3 RTDs failed.

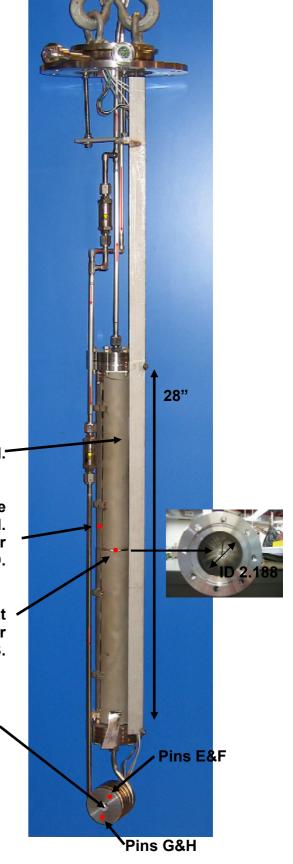
RTD is a 100 ohm platinum resistor with a 0.00385 Ω /°C temperature coefficient.

Thermocouples are Type K. Thermocouple wire goes from the sensor to a vacuum feed thru. The vacuum feed thru introduces some error because its pins are a different metal from that of the thermocouple wire. Another piece of thermocouple wire runs from the feed thru connector to the temperature controller.

Filter volume is 1.72 liters.

Filter regeneration heater clamshell.

One TC on the outside surface of the filter housing, under the clamshell. This TC is in a tube welded to the filter housing. Pins C&D.

One RTD inserted into a tube that extends into the middle of the filter material. Pins A&B.

Filter regeneration gas pre-heater.

Stainless steel tubing wrapped around an aluminum cylinder. Two TC sensors embedded in aluminum block for heater control. During cryo cool down, temperature sensors embedded in aluminum cylinder will trail tube temperature because of the poor thermal connection (line contact) between the tubes and cylinder.
